**Flood Control Project Maintenance
Levee Inspections**
LMA District Cover Sheet
Spring 2019 Levee Inspection Results

Reclamation District No. 0524 Middle Roberts Island

Spring 2019 Levee Inspection Results

Waterway			Bank	Unit Miles
Unit No. 01 San Joaquin River			Left	6.20
	Spring (March - May)	Summer (June - August)	(September - November) Fall	Winter (December - February)
Unit Maintenance Rating (Fall Only)				
Date of Inspection	3/26/2019 - 3/27/2019			
DWR Inspector	Alberto De Leon			
Accompanied By	Zach Jojola DWR

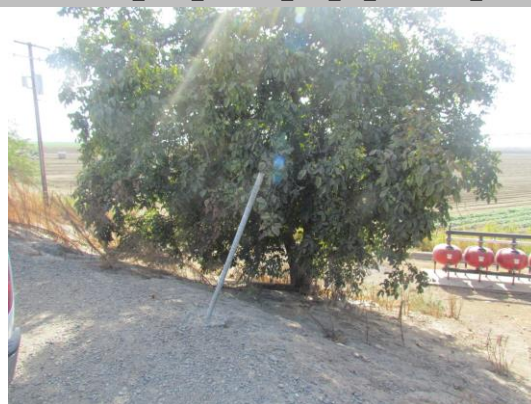
Photo 1 of 1 : SP_2019_RD0524_107_98_20190313_00132.jpg

LM Start	5.87	Rating **	M	Issue No.	98
LM End	5.87	Issue Type +	Ma	Location *	LS
Category	Earthen Levee			GPS Latitude/Longitude	
				Start	End
Item	Trim / Thin Trees			37.874085 °	37.874085 °
				-121.333154 °	-121.333154 °
DWR ID	DWR_RD0524_01_s_2012_98				
Comment Code					
T1 : Trim trees to at least five feet above ground level.					
Inspector Comment					
Untrimmed walnut tree on landside slope.

Looking west at walnut tree on landward slope.

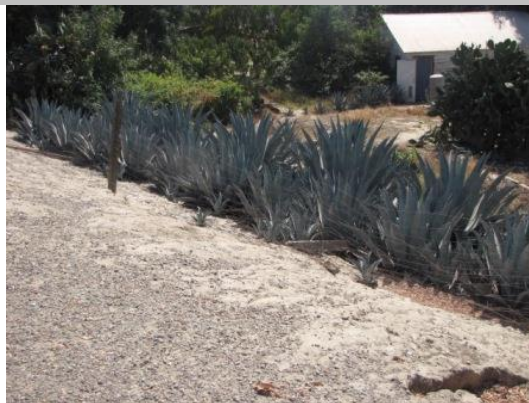
Photo 1 of 1 : SP_2019_RD0524_107_88_20190313_00119.jpg

LM Start	5.94	Rating **	U	Issue No.	88
LM End	5.95	Issue Type +	En	Location *	LS
Category	Earthen Levee			GPS Latitude/Longitude	
				Start	End
Item	Vegetation			37.873543 °	37.873445 °
				-121.332308 °	-121.332127 °
DWR ID	DWR_RD0524_01_s_2012_88				
Comment Code					
V6 : Landscaping					
Inspector Comment					
Cactus and Century plants on landside slope and toe.

Looking southeast at fence and cactus on landside slope and toe.

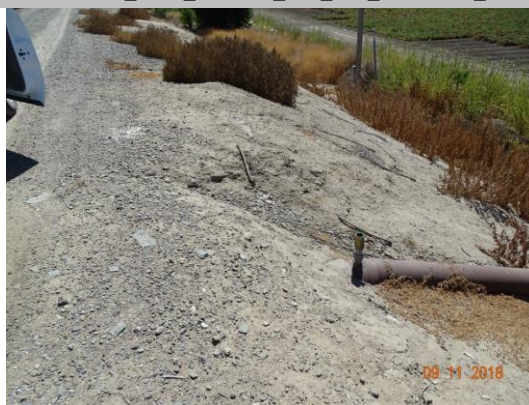
Photo 1 of 1 : SP_2019_RD0524_107_147_20190313_00148.jpg

LM Start	6.08	Rating **	M	Issue No.	147
LM End	6.08	Issue Type +	Ma	Location *	LS
Category	Earthen Levee			GPS Latitude/Longitude	
				Start	End
Item	Erosion / Bank Caving			37.872017 °	37.872017 °
				-121.330487 °	-121.330487 °
DWR ID	DWR_RD0524_01_f_2018_147				
Comment Code					
E1 : Note and monitor erosion site.					
Inspector Comment					
Erosion around and near pipe on landward slope.

Looking at landward erosion. (Fall 2018)

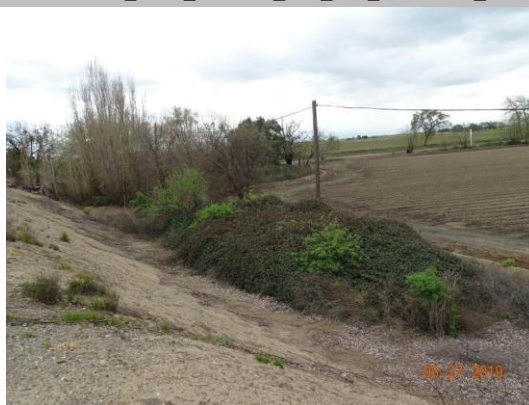
Photo 1 of 1 : SP_2019_RD0524_107_142_20190328_00394.jpg

LM Start	6.11	Rating **	U	Issue No.	142
LM End	6.11	Issue Type +	Ma	Location *	LS
Category	Earthen Levee			GPS Latitude/Longitude	
				Start	End
Item	Vegetation			37.871631 °	37.871631 °
				-121.330332 °	-121.330332 °
DWR ID	DWR_RD0524_01_s_2019_142				
Comment Code					
V2 : Remove the wild growth other than native grasses from the levee slopes.					
Inspector Comment					
Dense vegetation within landside easement blocking visibility.

Dense vegetation on landside toe. Spring 2019.

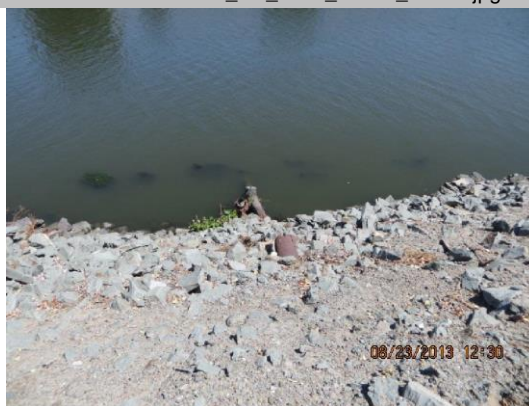
Photo 1 of 2 : UCIP_SP_2019_18392_30910.jpg

LM Start	6.15	Rating **	M	Issue No.	969
LM End	6.15	Issue Type +	En	Location *	
Category	Supplemental			GPS Latitude/Longitude	
				Start	End
Item	DWR UCIP Field Study			37.871138 °	37.871138 °
				-121.330146 °	-121.330146 °
DWR ID	20641				
Comment Code					
Inspector Comment					
FS_ID:18392					
DS_ID:20641					
EP_NO: N/A					
Repair Type: Non-Urgent					
Crossing Status: Found					
UCIP Comments: Pipe and pump abandoned and should be done so properly.					
FIELD_STRUCT_DESC: *ABANDONED* 10-inch irrigation pipe of an unknown material through the levee, 12 feet below the crown. Pump on the waterside (WS) slope. [Additional Reference(s): DWR Levee Log, 2004. USACE San Joaquin O&M Manual 7, April 1964, (HLM 6.22)].					
FS Date: 8/23/2013

Pump and open pipe visible on WS slope.

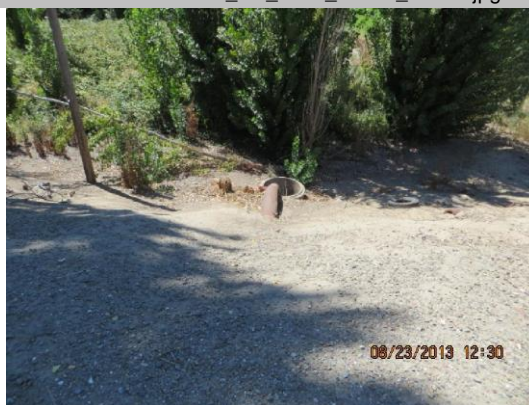
Photo 2 of 2 : UCIP_SP_2019_18392_30909.jpg

Pipe and concrete standpipe visible on LS toe.

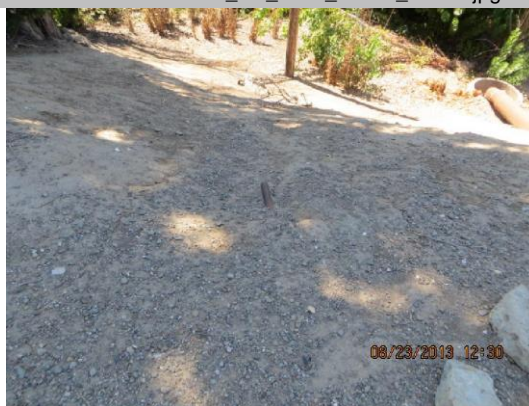
Photo 1 of 2 : UCIP_SP_2019_22073_37670.jpg

LM Start	6.15	Rating **	M	Issue No.	970
LM End	6.15	Issue Type +	En	Location *	
Category	Supplemental			GPS Latitude/Longitude	
				Start	End
Item	DWR UCIP Field Study			37.871118 °	37.871118 °
				-121.330137 °	-121.330137 °
DWR ID	24052				
Comment Code					
Inspector Comment					
FS_ID:22073 DS_ID:24052 EP_NO: N/A Repair Type: Non-Urgent Crossing Status: Found UCIP Comments: Abandoned and should be done so properly. FIELD_STRUCT_DESC: *ABANDONED* 1.75-inch galvanized iron electrical conduit through the levee, 1 foot below the crown. Power pole on the landside (LS) toe. FS Date: 8/23/2013

Pipe visible on LS slope.

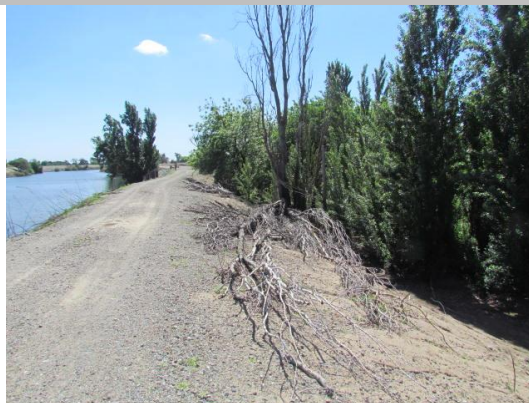
Photo 1 of 2 : SP_2019_RD0524_107_81_20190313_00113.jpg

LM Start	6.15	Rating **	M	Issue No.	81
LM End	6.15	Issue Type +	Ma	Location *	LS
Category	Earthen Levee			GPS Latitude/Longitude	
				Start	End
Item	Encroachments			37.871097 °	37.871097 °
				-121.330100 °	-121.330100 °
DWR ID	DWR_RD0524_01_s_2015_81				
Comment Code					
TR : Tree or limb					
Inspector Comment					
Fallen tree branches and limbs on landside slope.

Looking south at tree branches and limbs left on landward shoulder and slope. (Spring 2016)

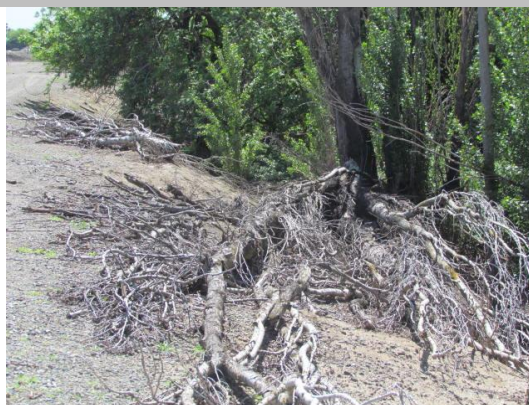
Photo 2 of 2 : SP_2019_RD0524_107_81_20190313_00114.jpg

LM Start	6.15	Rating **	M	Issue No.	81 (cont)
LM End	6.15	Issue Type +	Ma	Location *	LS

Looking west at tree branches and limbs left on landward shoulder and slope. (Spring 2016)

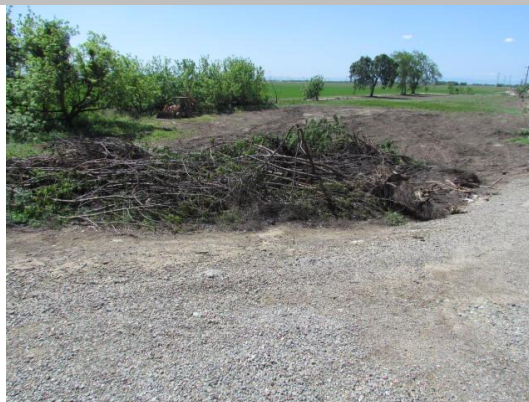
Photo 1 of 1 : SP_2019_RD0524_107_86_20190313_00118.jpg

LM Start	6.20	Rating **	U	Issue No.	86
LM End	6.20	Issue Type +	En	Location *	LS
Category	Earthen Levee			GPS Latitude/Longitude	
				Start	End
Item	Encroachments			37.870388 °	37.870388 °
				-121.329840 °	-121.329840 °
DWR ID	DWR_RD0524_01_s_2016_86				
Comment Code					
PR : Prunings					
Inspector Comment					
Large pruning pile left at landside toe.

Looking west at prunings at landward toe and berm.
